Installation of the Monitoring Site at the Los Alamos Canyon Low-Head Weir

Produced for the Cerro Grande Rehabilitation Project

*W. J. Stone
D. L. Newell**

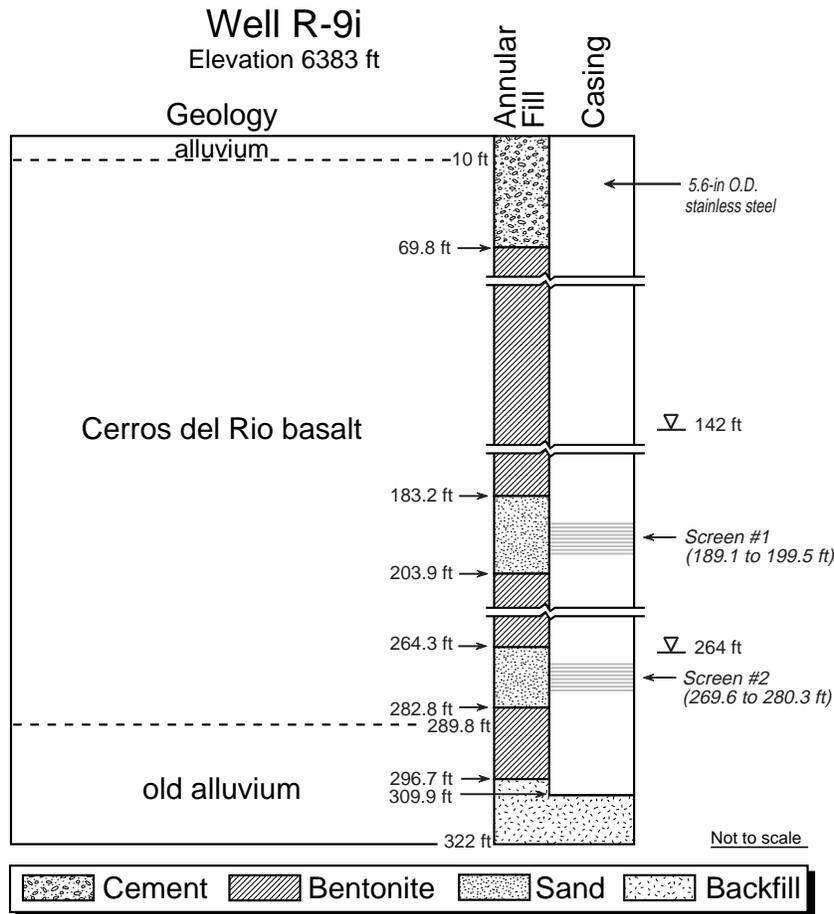
Figure 2. Hydrogeology and well construction at characterization well R-9i

Regional groundwater characterization wells R-9 and R-9i, located approximately 1/4 mi. west of the weir, provide a good picture of the hydrogeology of this portion of Los Alamos Canyon (Broxton et al. 2001, 71250; Broxton et al. 2001, 71251). These wells were installed under the Hydrogeologic Workplan (LANL 1998, 59599) to characterize the regional as well as any perched zones of saturation existing near the eastern Laboratory boundary. Well R-9 encountered four zones of saturation: two perched in the Cerros del Rio basalt, one perched in the Puye Formation and the one lying beneath the regional water table in Santa Fe Group basalt. The perched zones were sealed off and R-9 was completed with a single screen straddling the regional water table, which was encountered at a depth of 688 ft. Well R-9i was installed beside R-9 to permit monitoring of the perched zones in the basalt (Figure 2). Hydrologic testing at R-9i indicated the upper zone was much more productive than the lower zone (Table 2).

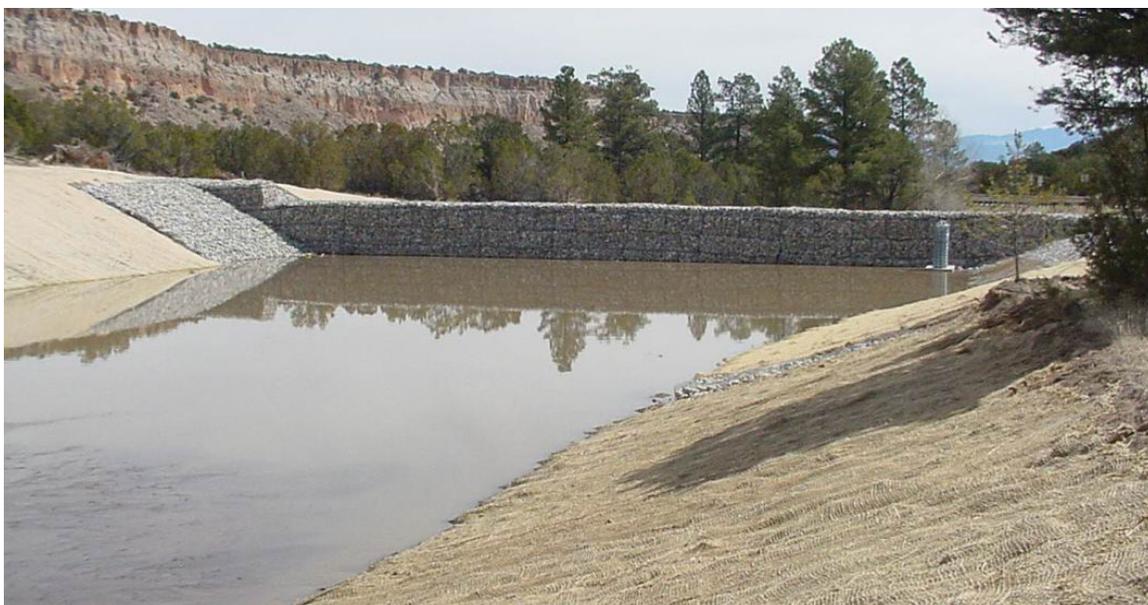
Figure 3. The Los Alamos Canyon low-head weir with ponded runoff (photo by Phil Stauffer)

The weir consists of a rock-and-mesh gabion situated downstream of a flat-floored channel area (Figure 3). The structure is classified as “low head” because water can pass through the gabion, and significant long-term ponding behind the weir should not occur. It was designed to cause particles larger than 80 microns in diameter to settle behind the weir.

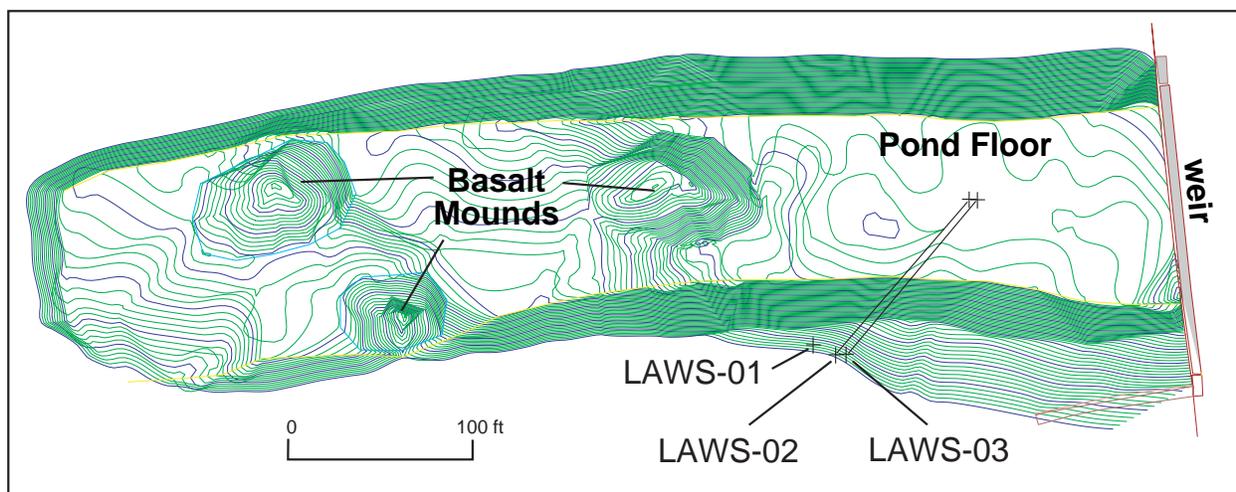
Figure 4. Detailed topographic map of the area behind the weir (prepared by Bill Kopp)

During such grading, mounds of basalt were encountered. As these mounds rose to a height above that planned for the flat area behind the weir, they were drilled in preparation for blasting so they could be removed. However, the San Ildefonso Pueblo expressed concern that the blasting could potentially affect sacred sites in the adjacent bluffs. In response to these concerns, the plans to remove the basalt mounds were abandoned and the blast holes were filled with cement grout. Consequently, the flat settling area upstream of the weir is approximately one-third of the size that was originally planned (Figure 4).

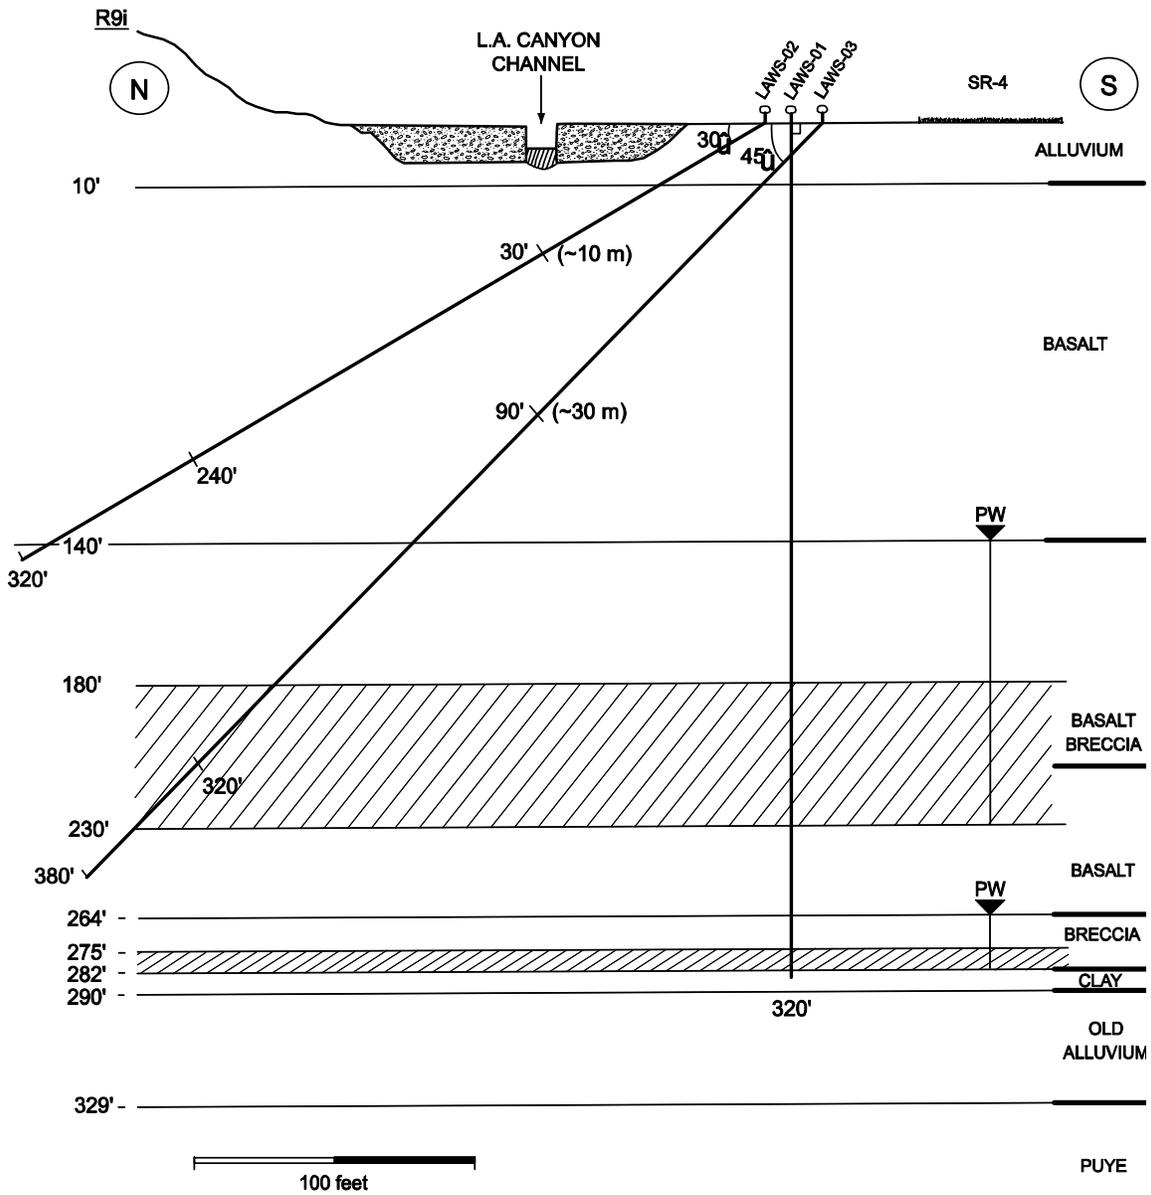
Figure 5. Planned design for well and boreholes

The original monitoring plan called for drilling three boreholes upstream of the weir: one vertical at the edge of the channel and two slant holes (at 45° and 30° from horizontal) extending out under the channel (Figure 5). These were to be aligned so that they would be drilled in the same vertical plane. The vertical hole was to be completed as a monitoring well with a single screen in the lower perched zone. The 45° hole was to be 380 ft long and instrumented with a flexible liner for monitoring both the upper perched zone and the unsaturated zone above it. The 30° hole was to be 150 ft long and instrumented to monitor only the unsaturated zone above the upper perched water. Based on drilling conditions at R-9 and R-9i, it was assumed that the holes would stay open, facilitating deployment of flexible liners for monitoring.

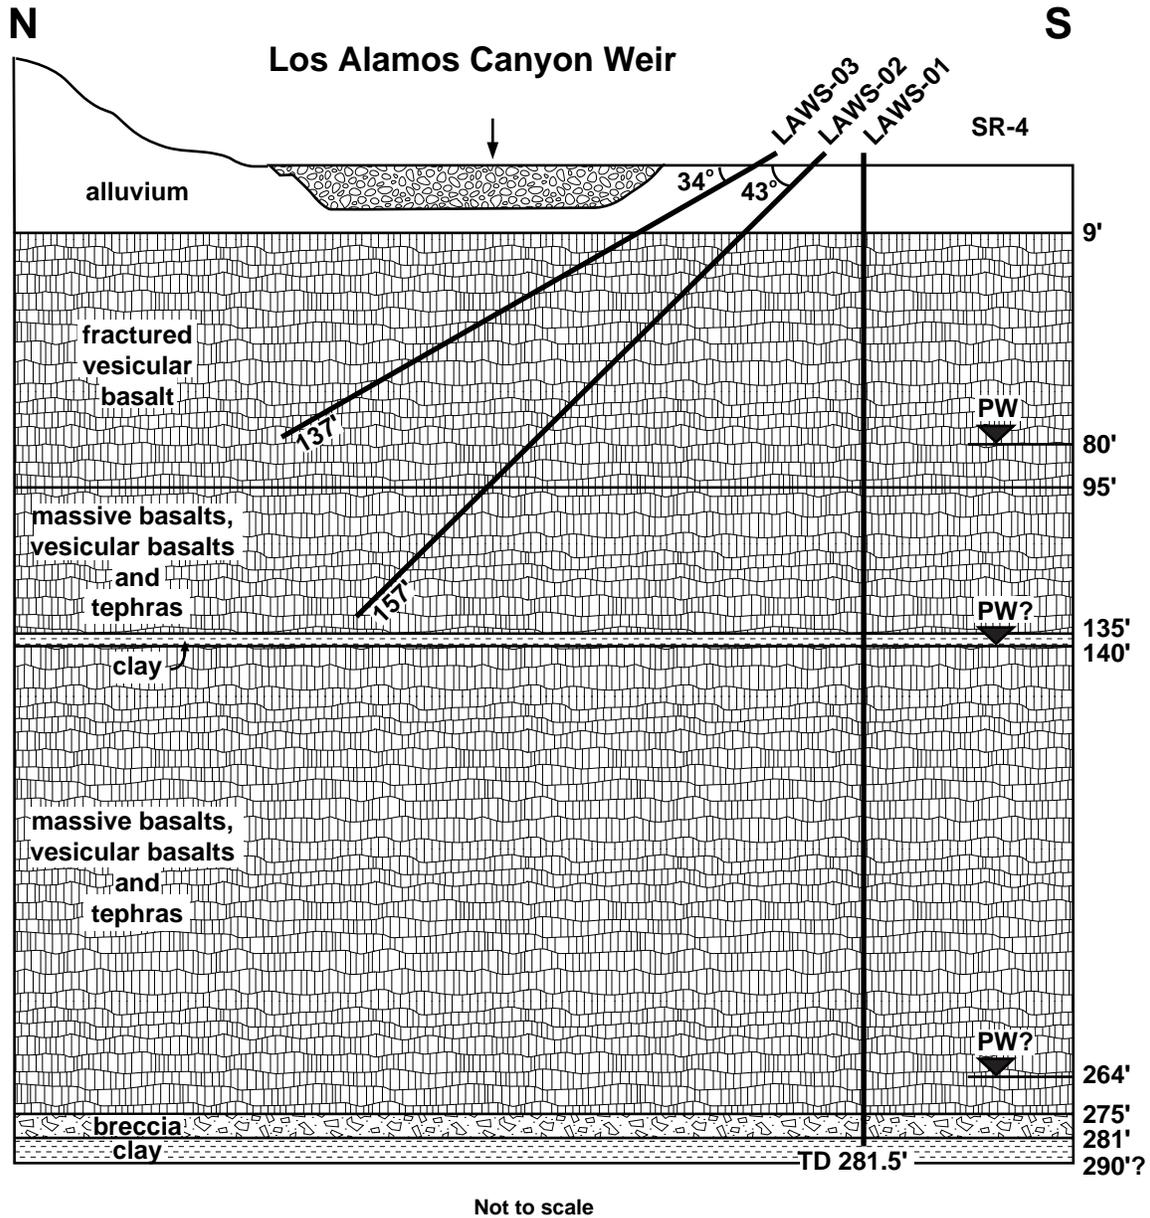
Figure 6. Actual configuration of well and boreholes

However, as is often the case, the design of the well and boreholes changed in response to conditions encountered during their installation. Because we were prohibited from drilling through the asphalt in the parking lot and space for adding fill north of the pavement was limited, it was not possible to drill the holes toward the pond area in the same vertical plane. This change did not affect the project goals, since such alignment could not guarantee that the same fractures would be penetrated by both angle holes. Nonetheless, the holes were placed as close together as practical while allowing enough space between them for well integrity and drilling-crew safety. Another change was warranted when it became clear that the vertical hole would not stay open and drilling had to be done by slower casing-advance methods. As a result, the slant holes were shortened and all saturated-zone tasks were moved to the vertical well (Figure 6). Furthermore, the use of flexible liners in the unstable angle holes required PVC shields (Stone 2002, 72663).

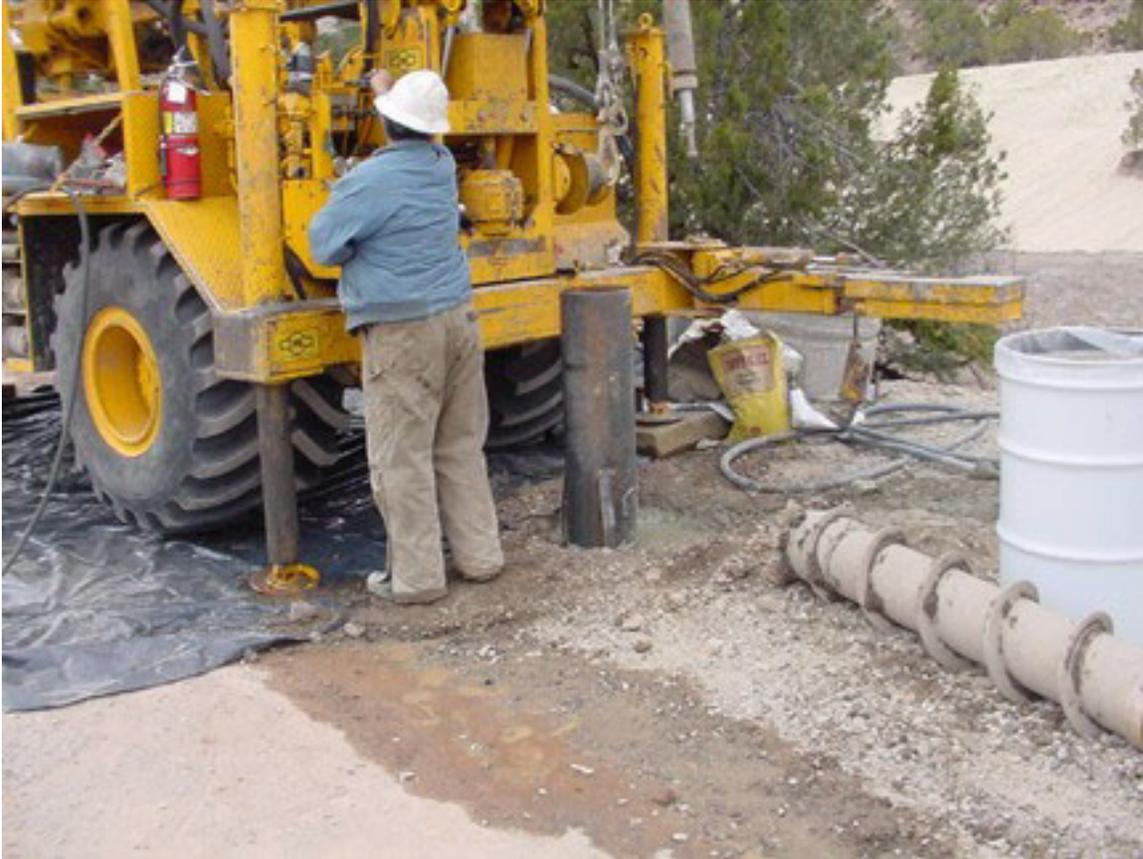
Figure 7. CME-750 auger rig setting surface casing at LAWS-01

Drilling proceeded in two phases. First, Stewart Brothers Drilling Co. (SBDC) augered three 12-in. holes (one vertical and two angled) to the top of the basalt (approximately 9 ft deep) using a CME-750 rig (Figure 7). SBDC then set 10 3/4-in. outside diameter (O.D.) steel surface casing in these holes. Next, Dynatec Drilling, Inc. (DDI), drilled the basalt to total depth (TD) by air-rotary, casing-advance methods with a Schramm T685W Rotadrill (Figure 8). The additional work on the 30° hole was accomplished with an underground drilling rig (UDR). No drilling fluid was used in any phase of drilling the holes.

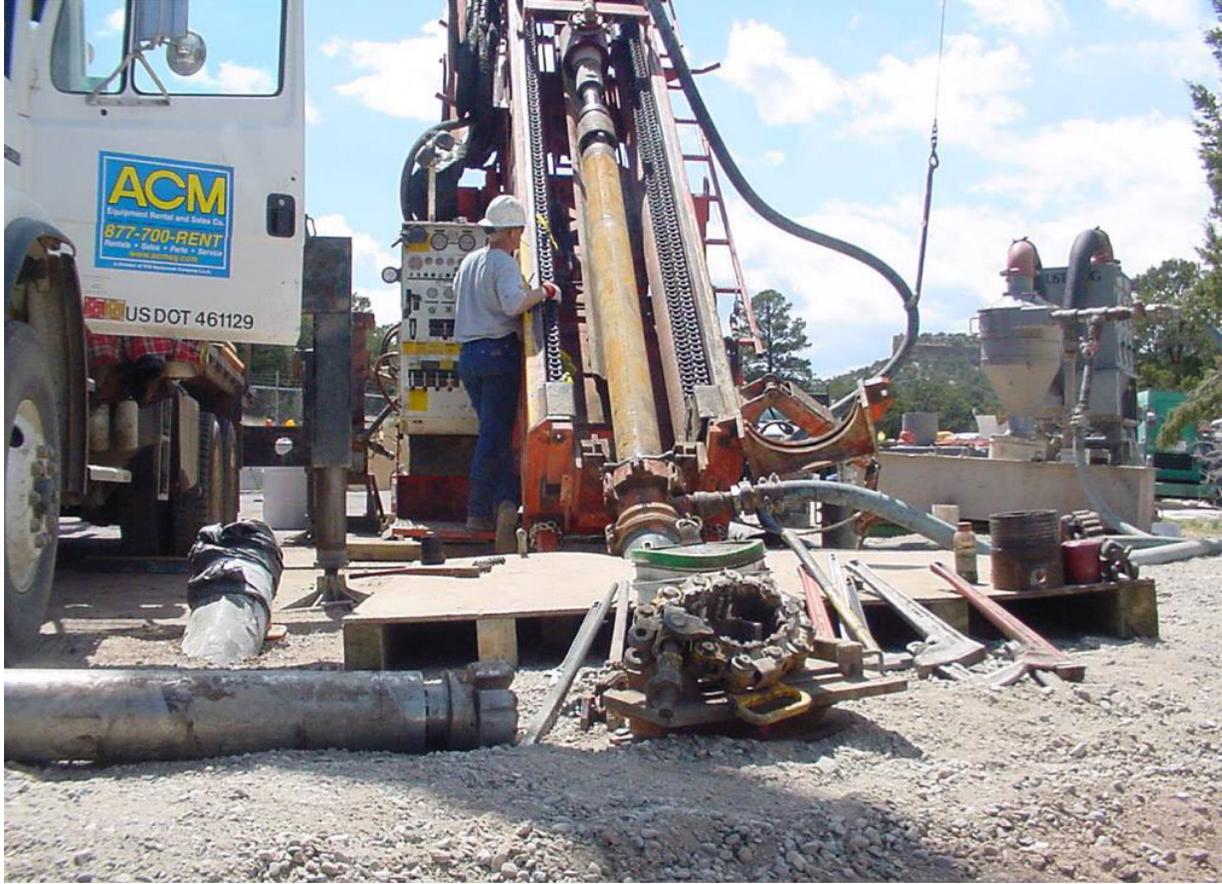
Figure 8. Schramm rotary rig drilling LAWS-02 by casing-advance method

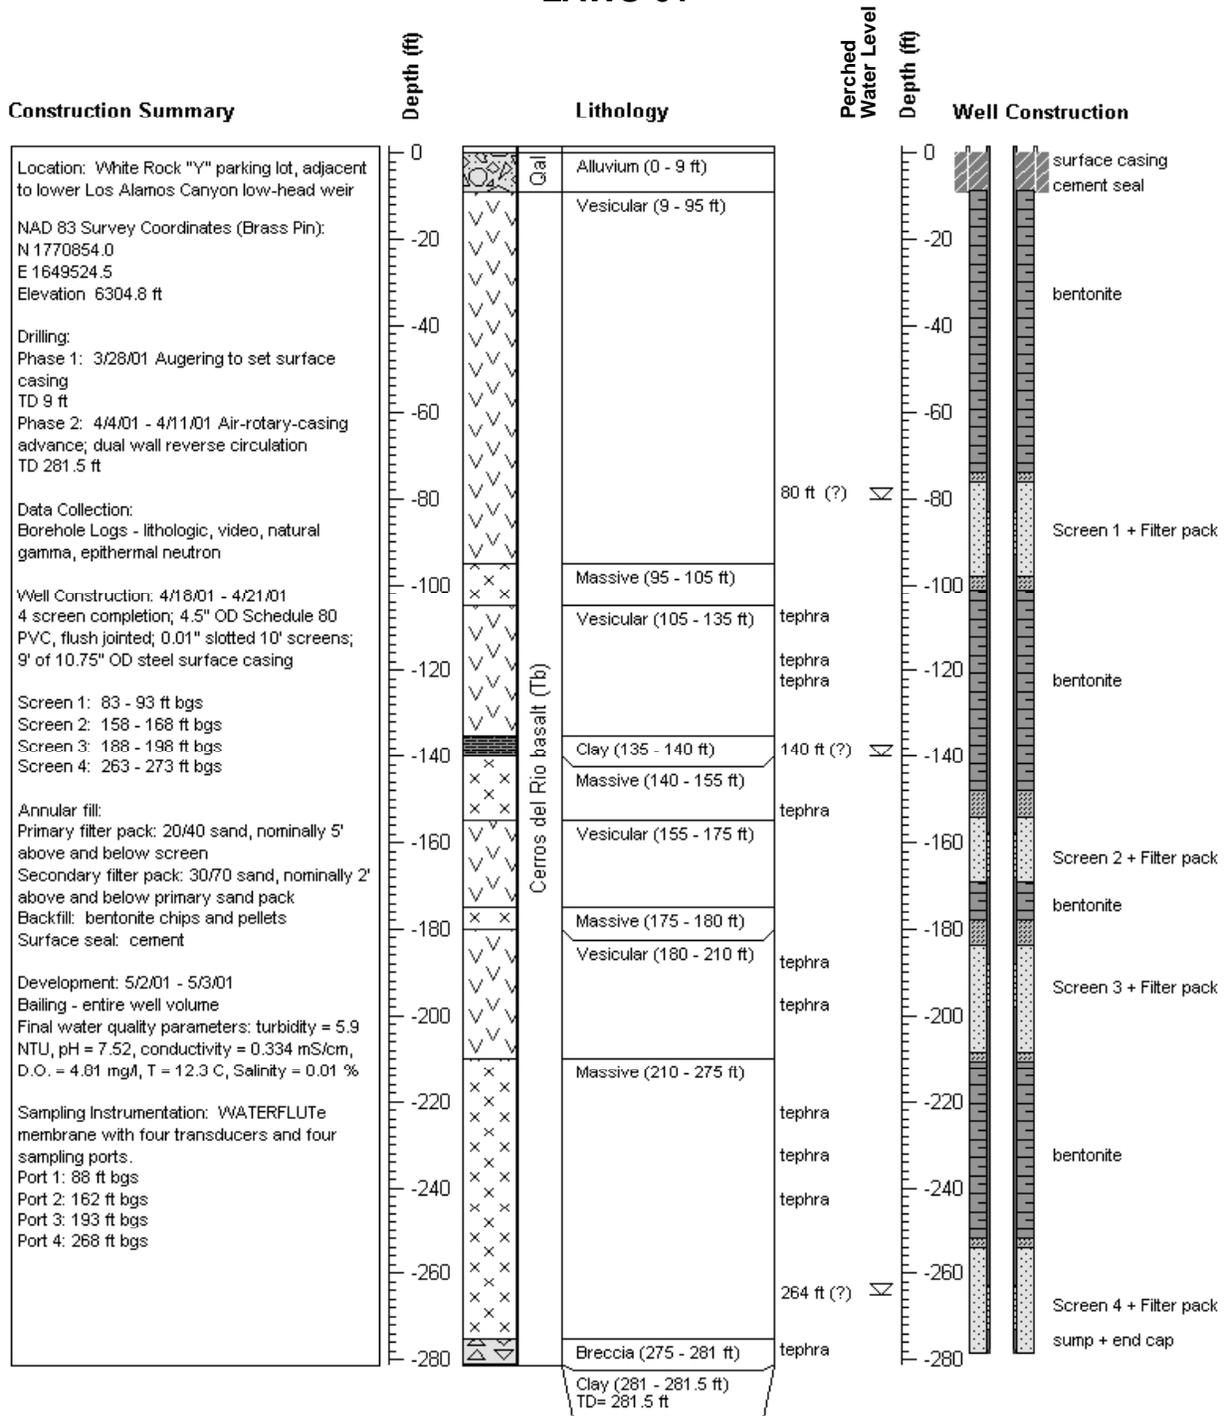
Figure 9. Geology, construction, and perched water levels at LAWS-01

LAWS-01 mainly penetrates a sequence of lava flows in the Cerros del Rio basalt (Figure 9 and Appendix A). The upper 9 ft of LAWS-01 includes fill, soil, and alluvium, respectively. The alluvium consists mainly of dacitic gravel up to cobble size. Vesicular olivine basalt extends from the base of the alluvium to a depth of 95 ft bgs. Clay coatings and vesicle infillings as well as oxidized surfaces are common. Video logging in the open hole to 74 ft bgs showed that the basalt is highly fractured. The fractures appear to be open and subvertical in orientation. Between 95 ft and approximately 130 ft is a mix of vesicular and massive layers of basalt. Matrix consisting of very fine-grained glass and black lithics occurs in the 95–100, 105–110, and 115–125 ft bgs intervals. The matrix is interpreted to be basaltic tephra, possibly marking individual eruptive events and flow boundaries. At a depth of 130 ft, the vesicular basalt is mixed with light brown smectitic clay. Clay increases in abundance to 135 ft, where a prominent clay horizon exists. The clay extends to a depth of 140 ft. From 140 to 145 ft, the clay horizon grades into massive basalt. Alternating vesicular and massive units extend to 275 ft bgs. Multiple zones rich in tephra exist throughout this section, especially at 150–155, 185–190, 195–205, 220–225, 230–235, and 240–245 ft bgs. Tephra are associated with both vesicular and massive basalt intervals. A basaltic breccia horizon occurs between 275 and 281 ft bgs. The breccia consists of vesicular and massive basalt chips with oxidized coatings and smectitic clay chips. At 281 ft bgs, a clay/tephra horizon exists, consisting of light brown smectite clods with very fine-grained black lithics. We did not plan to fully penetrate this interval, as it is the perching horizon for the lower saturated zone. Thus, its thickness is not known at the weir.

While the vertical hole was being drilled, saturated conditions were first encountered at a depth of 80 ft (Figure 9). This is 60 ft above the position anticipated for the upper perched zone, based on data gathered at characterization well R-9i. The amount of water decreased with depth, and cuttings were dry between 100 and 105 ft. This perched water may be related to seepage of the water that was ponded behind the weir when drilling began. There had been standing water behind the weir for 1 to 2 months before drilling commenced. The position of deeper perched water was masked by drainage from this upper zone. All cuttings below a depth of 105 ft bgs were wet. Thus, perched water levels shown on Figure 9 are estimates, based on observations at R-9i.

The vertical hole was completed as a conventional monitoring well with four 10-ft screens and a 10-ft sump (Figure 9). The production casing is 4.5-in. O.D., Schedule 80 PVC. The screens are 0.01-in. slotted PVC. Primary filter pack (20/40 sand) was installed from 5 ft below to 5 ft above the screens. To keep bentonite from reaching the primary filter pack and eventually the screen, we emplaced secondary (finer) filter pack (40/70 sand) 2 ft below and above the primary filter pack. The space between screens (that is, between secondary filter packs) was filled with bentonite pellets and chips. Some EZ-MUD® was added to the bentonite to delay hydration during placement through the tremie pipe.

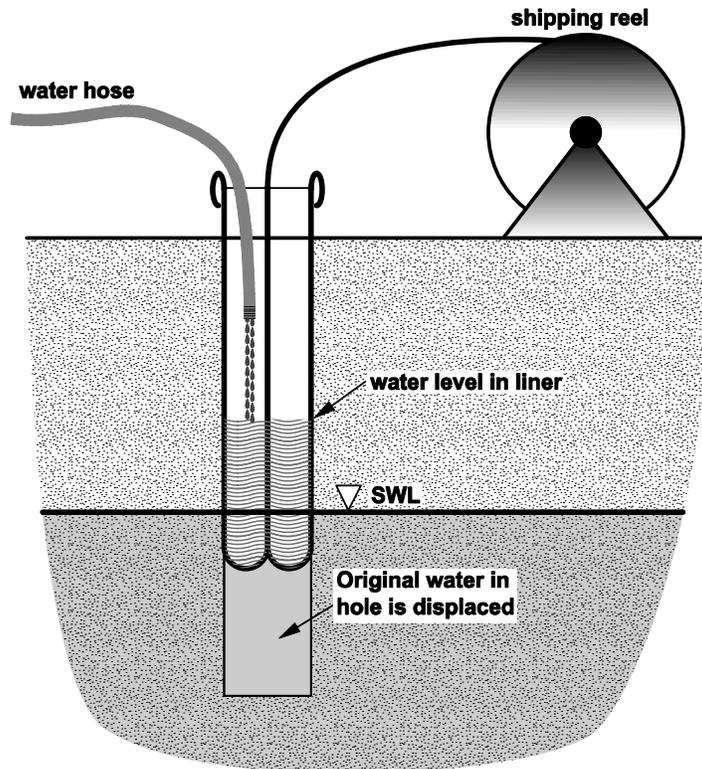
Figure 10. Schematic diagram showing deployment of a Water FLUTE™ system; water inside liner is isolated from the natural groundwater

LAWS-01 was instrumented with a flexible liner (Water FLUTE™) carrying four transducers and four sampling ports (Appendix B). Figure 10 shows the theoretical deployment of a Water FLUTE™ system. Figure 11 shows the installation of such a system at LAWS-01. Table 3 gives the specific location of ports for the liner installed in well LAWS-01. Although the transducers were placed near each other at the bottom of the well (at depths of 265-268 ft), each monitors a specific screen at shallower depths by means of tubing (Table 3). More specifically, one transducer is connected to the upper screened interval to monitor the seasonal upper saturation beneath the pond. Two are connected to the middle perched zone (corresponding to upper zone at R-9i) to determine whether this water is confined, as considered possible by some from R-9/R-9i data. The fourth transducer is associated with the bottom screen to measure head in the lower perched zone.

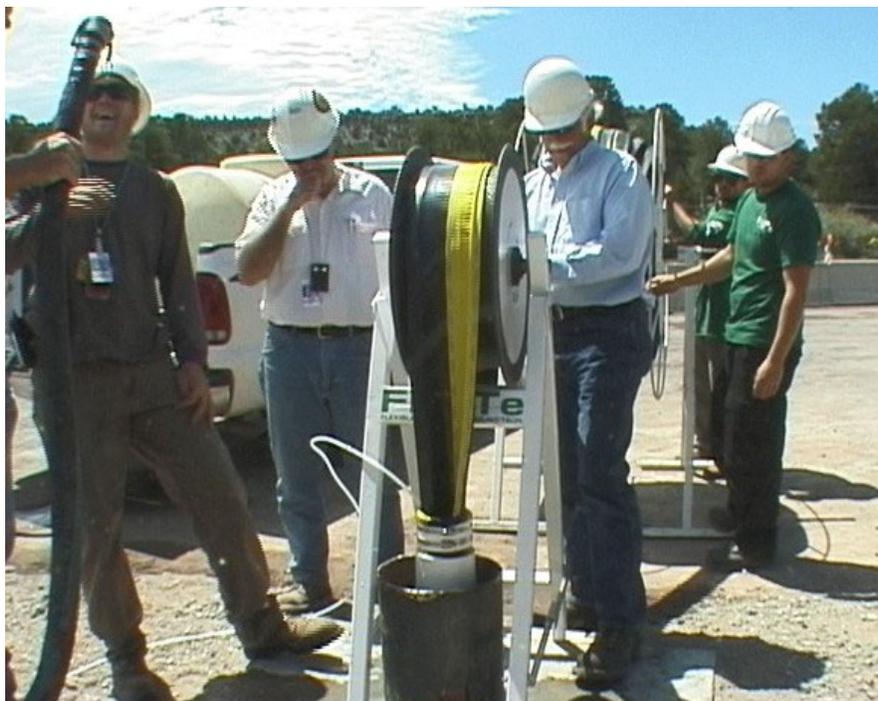
Figure 11. Installing the Water FLUTE™ system at LAWS-01; hose at left will deliver water to the inside of the liner for everting it into the well

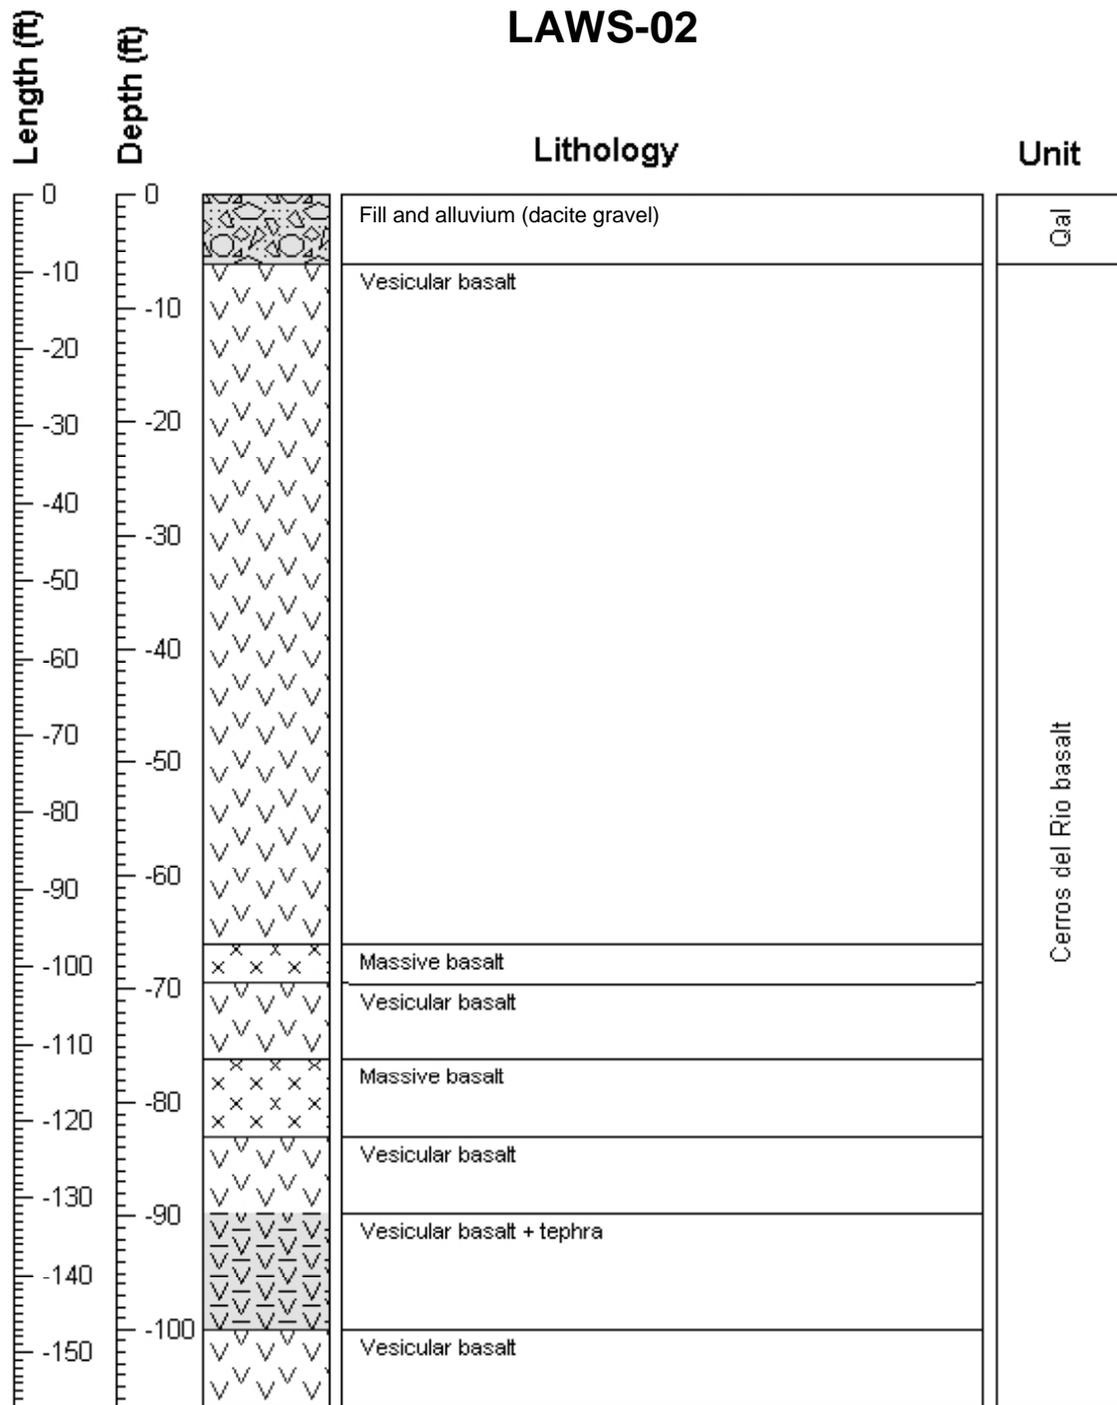
Figure 12. Geology along angled borehole LAWS-02

The geologic section encountered at LAWS-02 is very similar to that at LAWS-01 (Figure 12 and Appendix A) because of their proximity. The hole penetrated approximately 7 ft of fill, soil, and alluvium, respectively, comparable to the thickness of these materials at LAWS-01. Vesicular olivine basalt underlies the alluvium to an extent (along the inclined hole) of 156 ft bgs. Two thin intervals of massive basalt were encountered at a depth bgs of 65–69 ft and at a depth bgs of 76–83 ft. Vesicular basalt, rich in clay and tephra, occurs from 90–100 ft along the borehole.

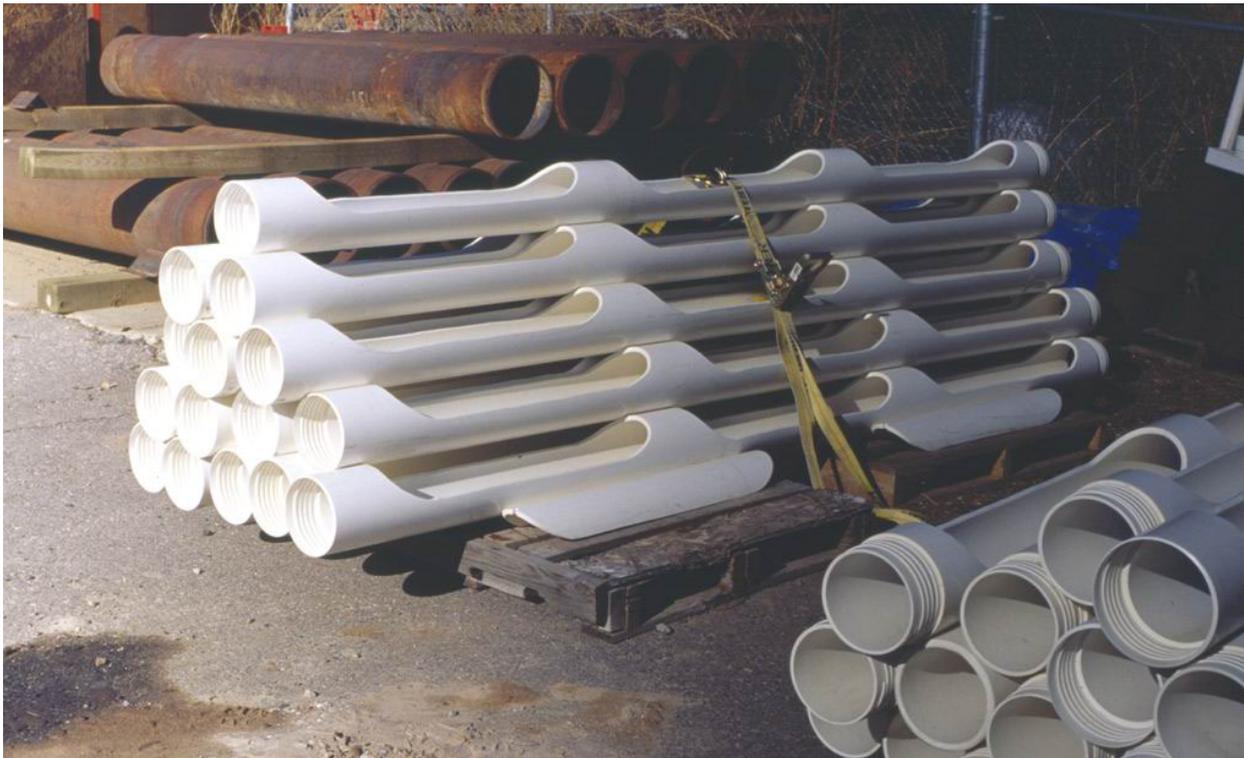
Figure 13. Scalloped PVC shield for liners in LAWS-02

Construction of the angled holes at the weir site presented a problem. Since the ground was found to be unstable, the holes had to be kept open when the casing was pulled. However, flexible liners, as planned for use in the slant holes, need to be in direct contact with the rock in the borehole wall. Although liners do not work through the small openings associated with screens, we expected that they would work through larger openings. Thus, we decided that a scalloped casing or shield would be inserted, before pulling drill casing, to keep the hole open while permitting the liner to contact the rock (Figure 13). More specifically, we installed 6-in., schedule-80 PVC, in which 30-in. long scallops had been cut on one side with a band saw at 6-in. intervals (three in each 10-ft piece). As a measure against separation, the threaded connections were secured with sheet-metal screws through both PVC joints. The as-built diagram for LAWS-02 is given in Appendix C.

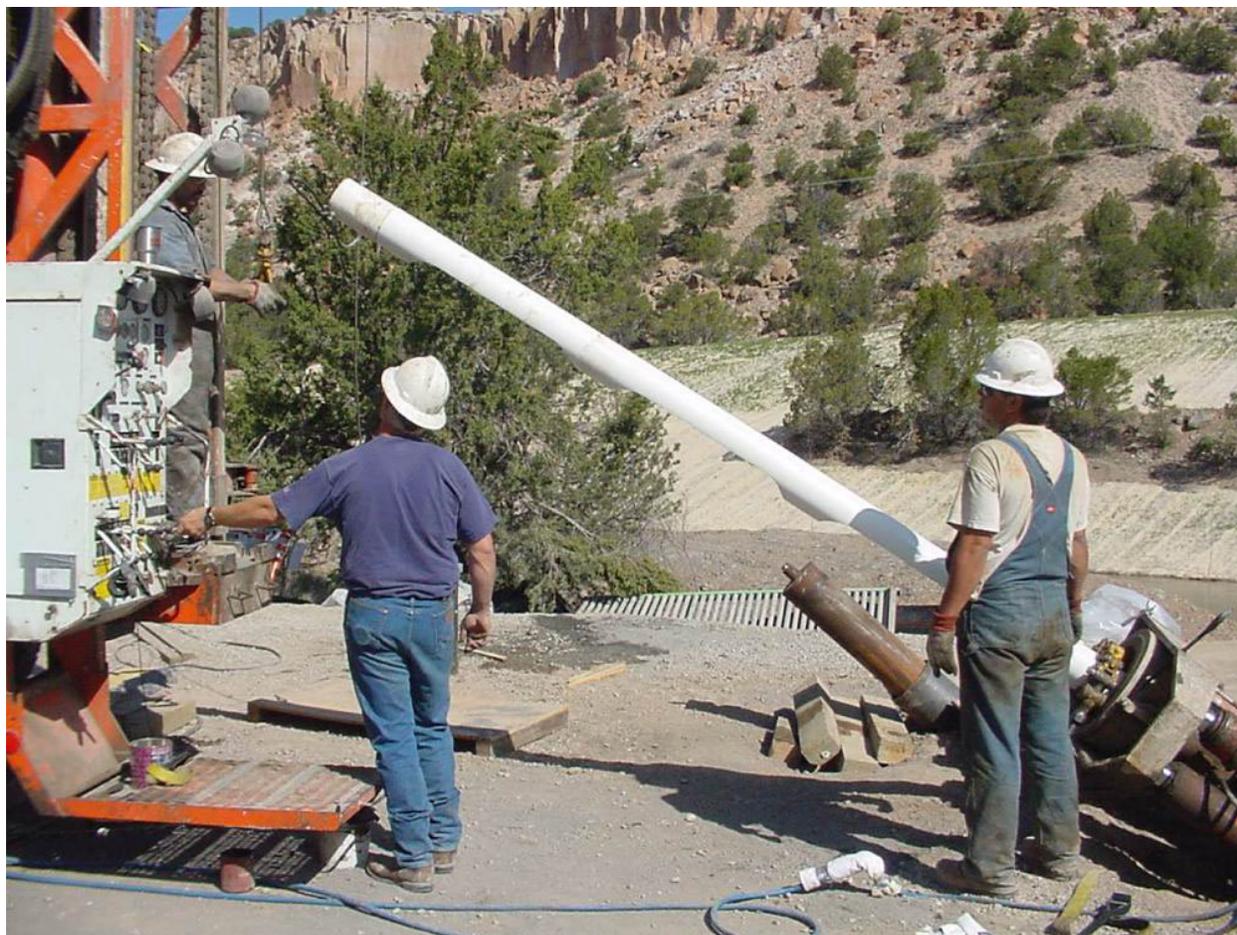
Figure 14. Constructing LAWS-02 with scalloped PVC

Every effort was made to emplace the PVC with the scallops at the bottom to avoid the possibility of rock debris falling in when the casing was retrieved (Figure 14). However, because considerable weight had been removed by cutting the scallops, the PVC would not stay in the intended orientation (i.e., scallops down). This problem was remedied by alternating scalloped lengths of PVC with blank lengths. This arrangement reduced the number of openings along the borehole but returned enough weight that the PVC no longer immediately rolled scallops-up when inserted through the steel casing. However, some rotation of the PVC when the casing was pulled was unavoidable, and thus the scallops were positioned between 6 o'clock (at the bottom of the hole) and 3 o'clock. As the scallops were not on the top, casing was not a problem. The steel casing was pulled without the use of jacks. Once the casing had been pulled back far enough for the PVC to extend beyond it, the basalt collapsed enough to hold the PVC in place.

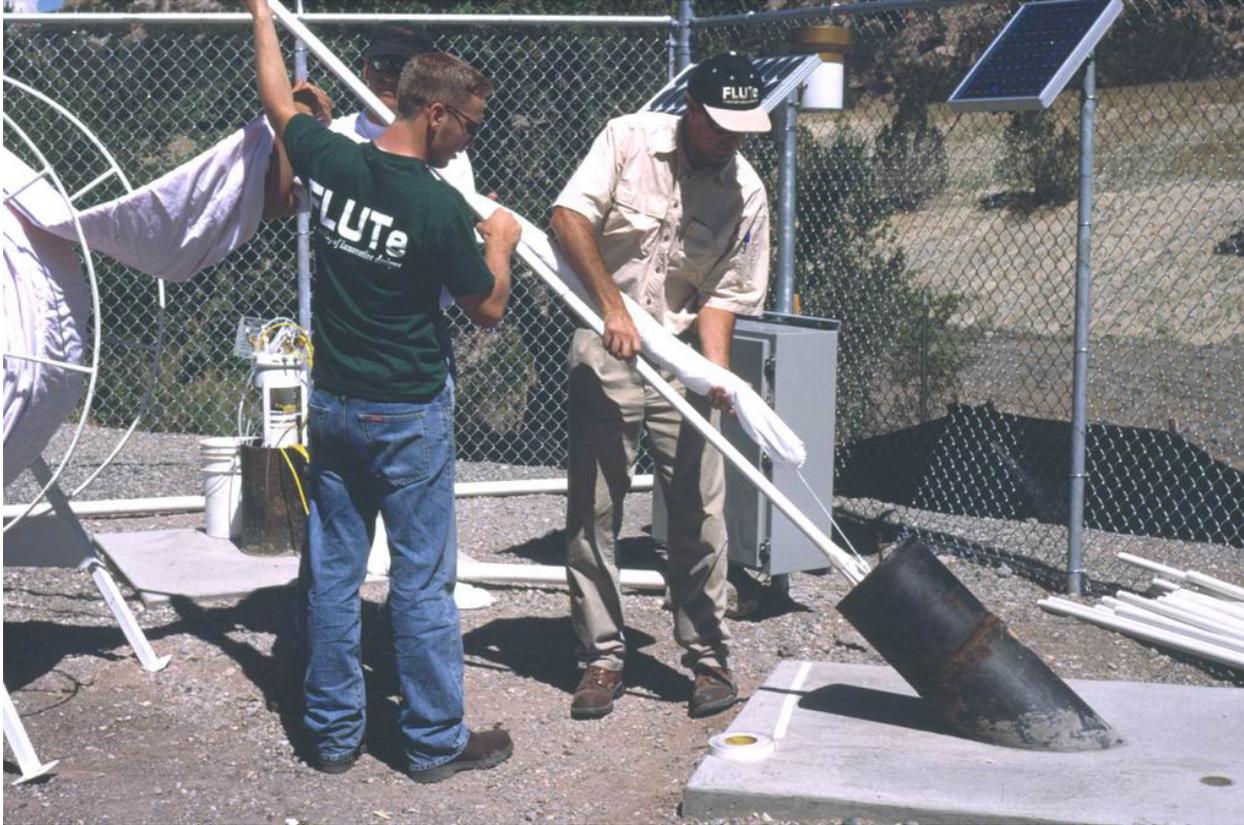
Figure 15. Installing the color-reactive liner in LAWS-02

A 6-in. diameter liner, consisting of color-reactive (red crepe) paper covered by soft, white cotton cloth, was installed first to detect moisture-bearing zones. Normal eversion of the liner by inflation was unsuccessful because of the size and location of the scallops. The liner became lodged against the lower edge of the first scallop it encountered and then tried to evert out through the opening into the sizable annulus existing between the PVC and the borehole wall, especially at local washouts.

To overcome the annulus problem, an 11-in. diameter liner was deemed large enough to expand through the scallops out to the borehole wall when inflated (except in washouts). To facilitate installation, we inserted it into the hole uninflated (Figure 15). To get past the scallops, we bundled and tied it at intervals with weak string. To streamline the bottom of the liner, we placed a short interval in a Tyvek™ sleeve attached to the end of a 1-in. PVC ramrod. A centralizer on the ramrod kept the liner from deflecting out the scallops. When the liner was partially inflated, the string broke and the ramrod, sleeve, and centralizer were recovered. Installation was completed by fully inflating the liner.

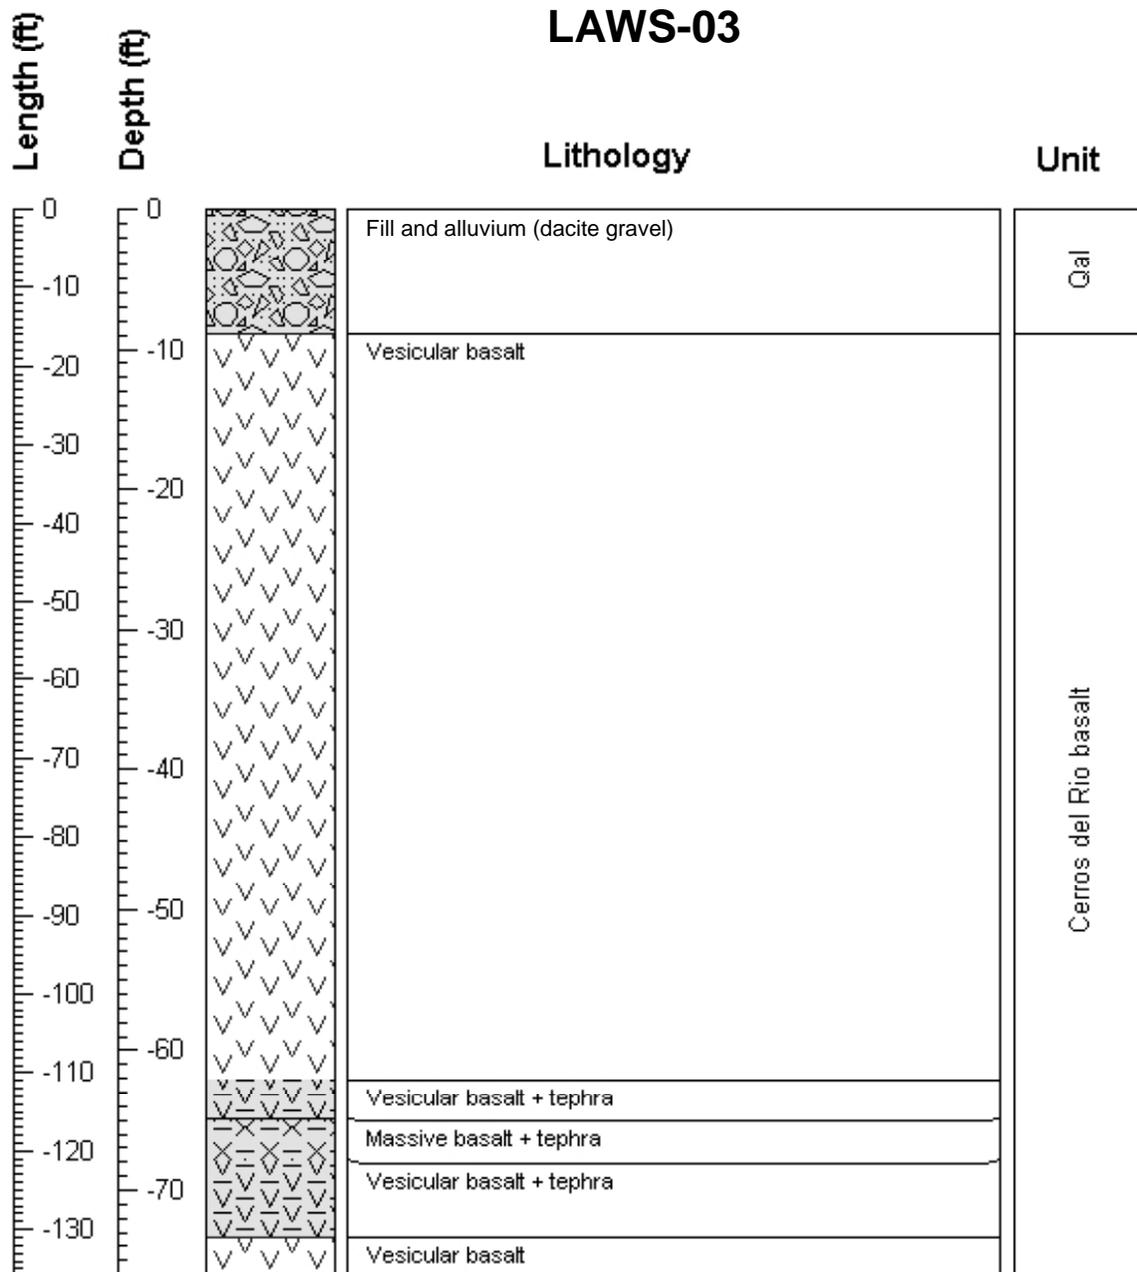
Figure 16. Geology along angled borehole LAWS-03

The geologic sequence is essentially the same as seen in the other two holes (Figure 16 and Appendix A). LAWS-03 penetrated approximately 7 ft of fill/topsoil/alluvium, respectively, and 70 ft of Cerros del Rio lavas. The lavas are primarily vesicular olivine basalts, like those found in LAWS-01 and LAWS-02. Tephra matrix between depths bgs of 62 and 73 ft is associated mainly with vesicular basalt but also with a small interval of massive basalt.

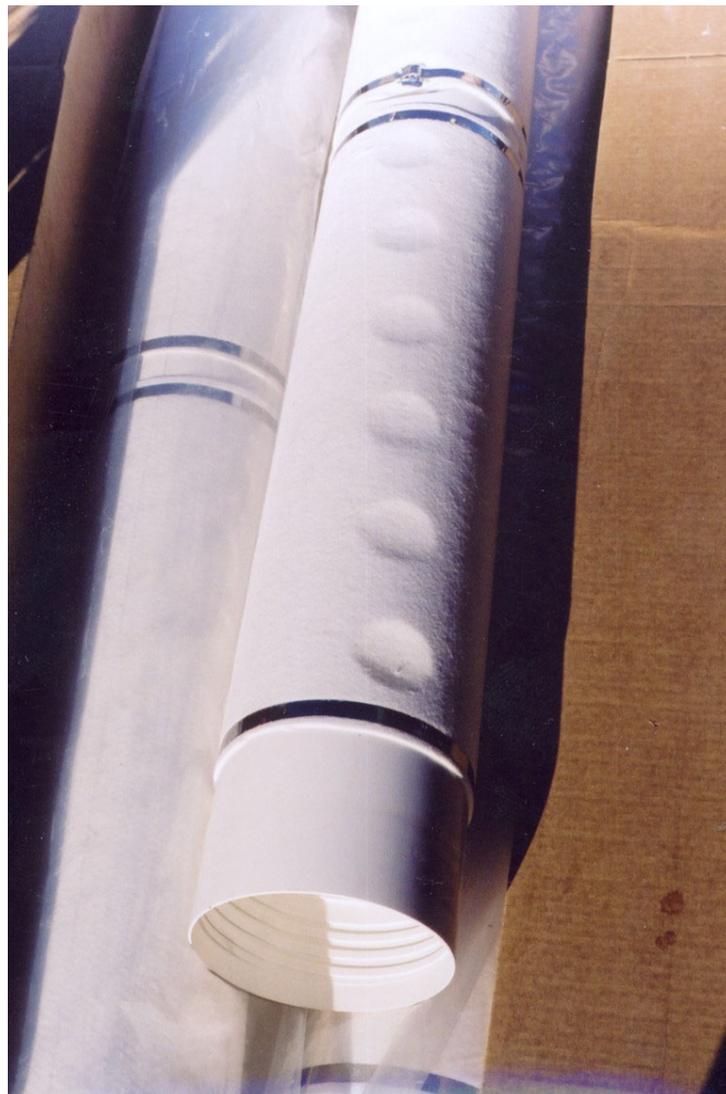
Figure 17. Perforated PVC shield (covered with wicking fabric) for liners in LAWS-03

Perforated PVC. On 20 February 2002 we decided that the scalloped PVC shield should be removed and a different shield that did not require orientation in the borehole should be installed. The replacement shield was made of 6 1/2-in. schedule-40 PVC in which 2-in. holes had been drilled in two intersecting spiral patterns (Figure 17 and Appendix C). To enhance collection of soil water at LAWS-03, we wrapped the perforated PVC with a layer of felt wicking fabric in discrete segments so that the source of any water collected could be identified. More specifically, approximately 2-ft-long expanses of wicking material were tightly clamped top and bottom to the outside of the PVC. This measure also reduced the possibility that the entire wicking layer could be stripped from the PVC as it was inserted into the borehole or when casing was pulled.

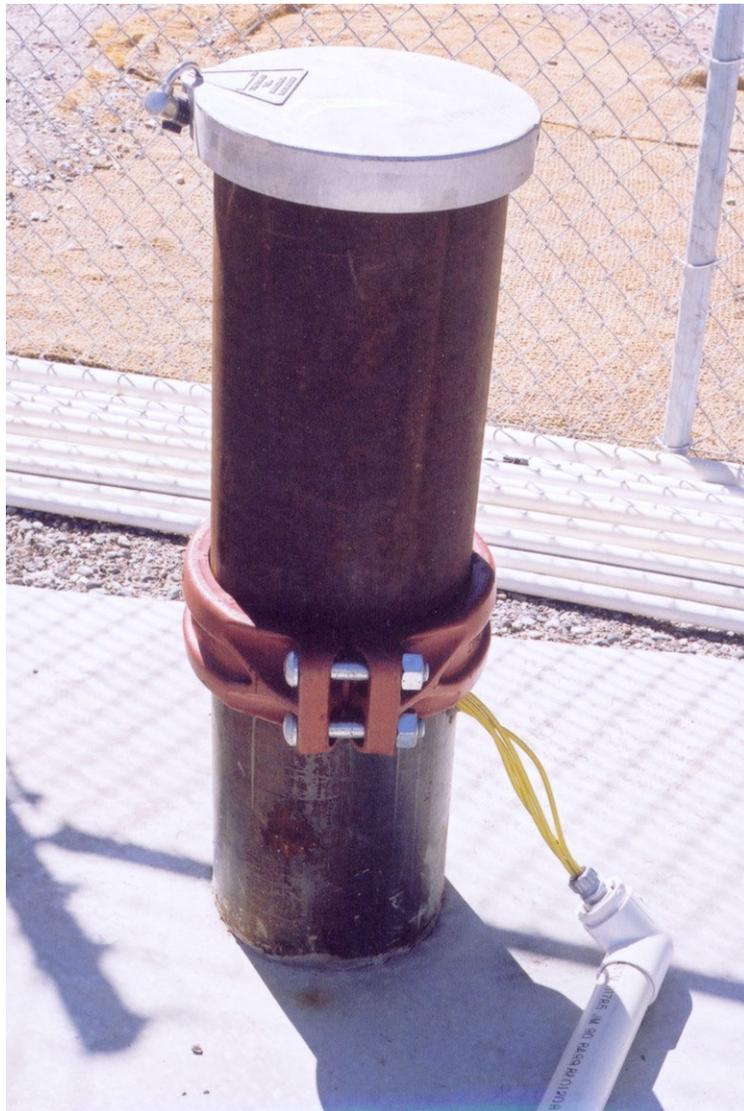
Figure 20. Wellhead protection for LAWS-01

The site represents a unique source of data as well as a considerable investment. Thus, protective measures were taken to provide for both data integrity and equipment security. At each hole, surface casing was extended well above ground level for easy access. Tubes associated with the liners are gathered and organized with special fixtures at the wellhead (Appendix D). Wellhead protection is provided by steel casing extensions with locking covers (Figure 20). The casing extensions and concrete pads constructed around each wellhead provide sanitary seals. Conduits protect cables on the ground surface between the wellheads and the equipment shelters from both the elements and small animals with a propensity to gnaw.
