Installation of the Monitoring Site at the Los Alamos Canyon Low-Head Weir

Produced for the Cerro Grande Rehabilitation Project

*W. J. Stone
D. L. Newell**

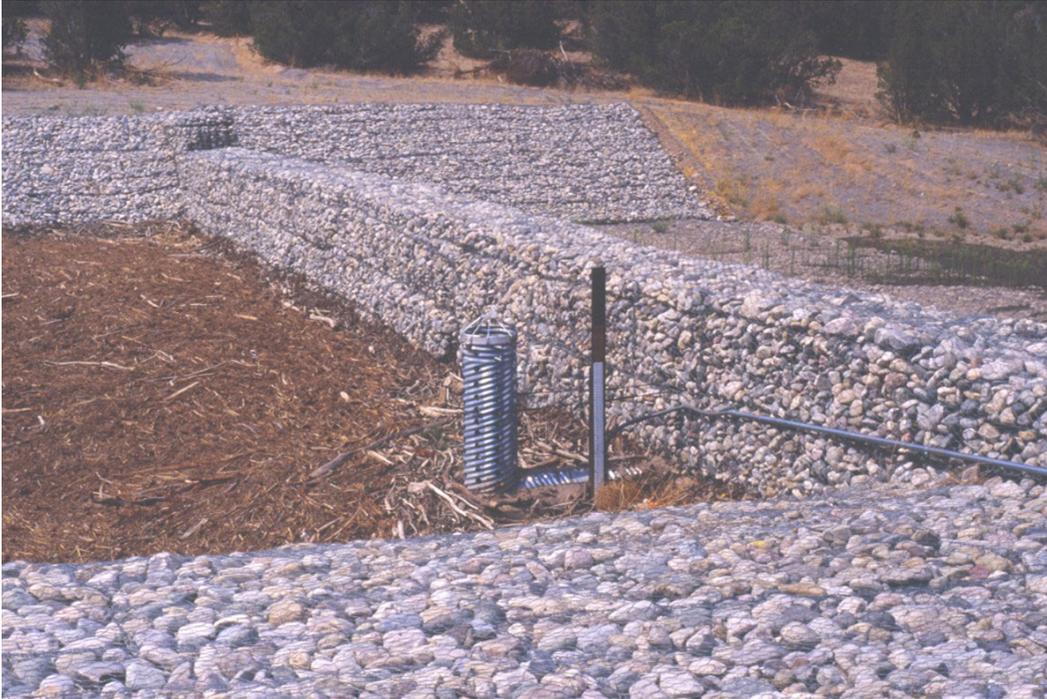
Figure 22. Pond gaging equipment upstream of the weir

Surface-water data are essential for evaluating and modeling unsaturated flow and transport at the weir. Thus, some means of monitoring surface-water phenomena must be available. The depth of water ponded upstream of the weir is provided by a staff gage with a bubbler and Sutron 8210 data logger, installed by LANL in the summer of 2001 (Figure 22). Additionally, the amount of water lost to the subsurface during flow past the weir can be determined by comparing discharge data taken at stations above and below the structure. A gaging station (E042) already existed approximately 1/4 mi upstream of the weir site, near R-9i (Shaull et al. 2001, 72609). However, to evaluate the impact of the weir, another station was needed downstream of the structure. Thus, in the summer of 2001, LANL installed another complete gaging station (E050) in Los Alamos Canyon below the weir (Figure 23). It consists of the same instrumentation as at the pond but has an ISCO™ automatic sampler as well.

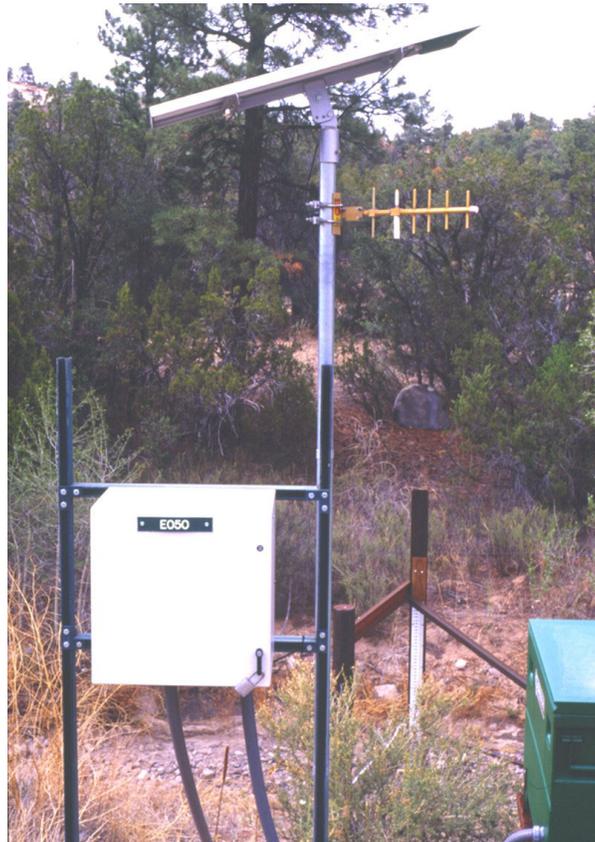
Figure 23. Stream gaging and sampling station downstream of the weir

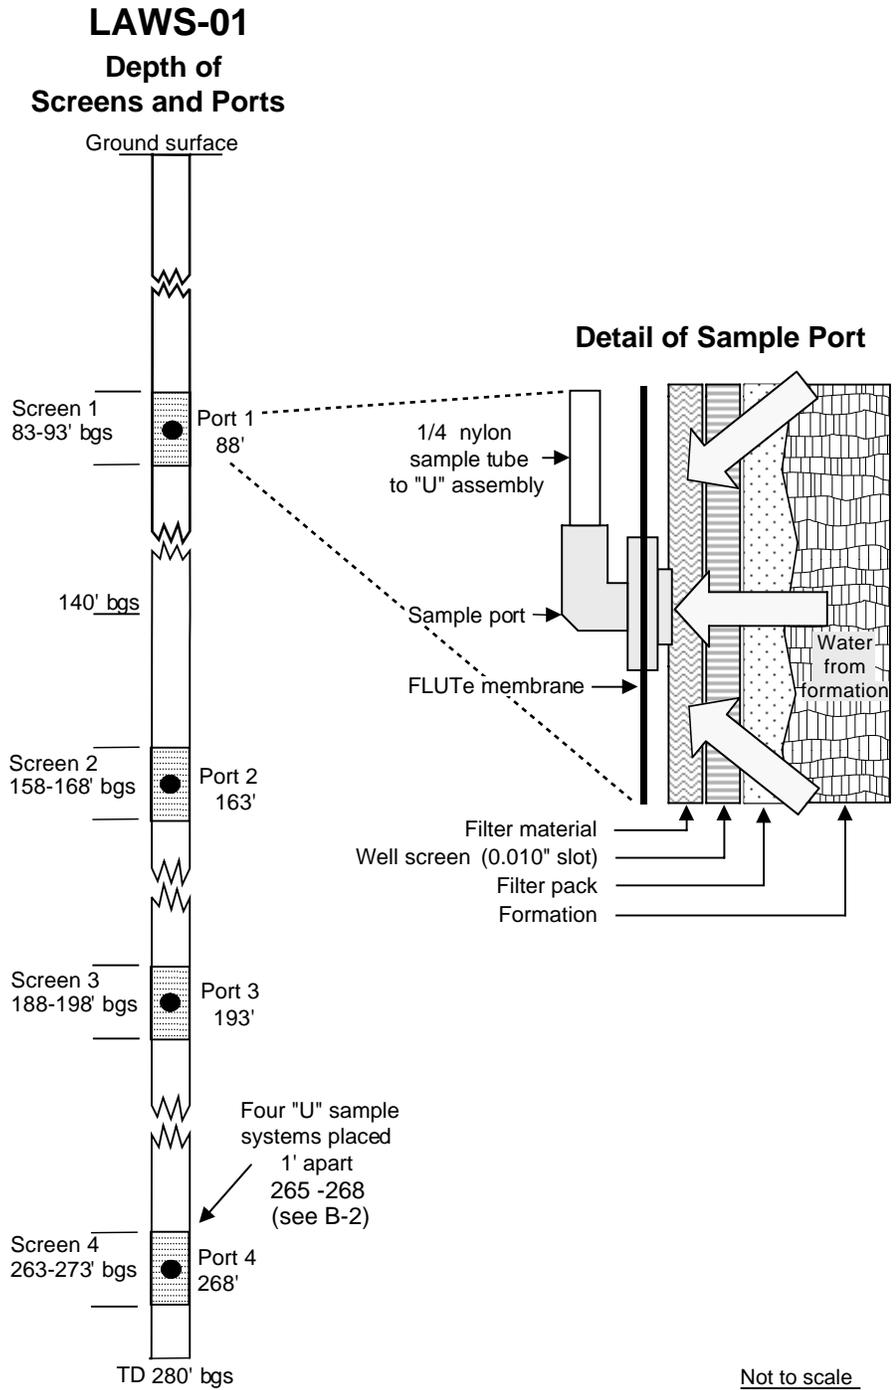
B-1. Location of sampling and transducer ports in LAWS-01 liner

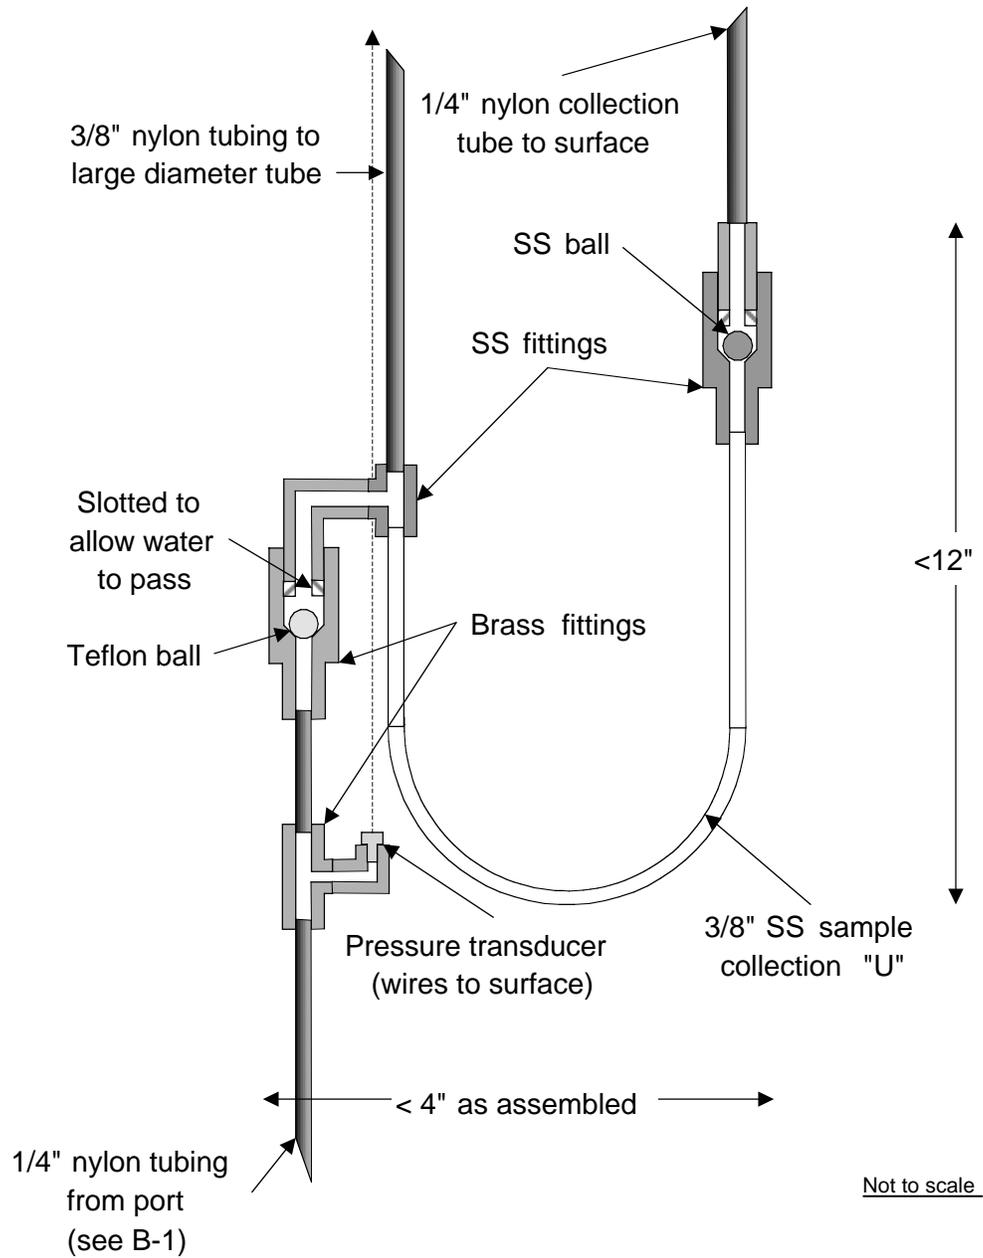
B-2. Schematic diagram of sampling assembly employed in Water FLUTE™ systems

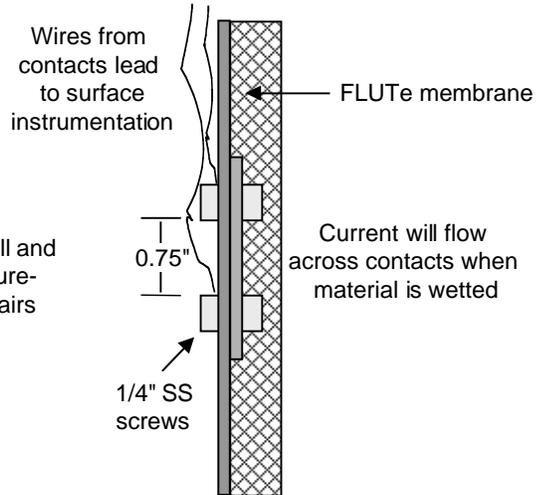
Detail of Wire Pairs

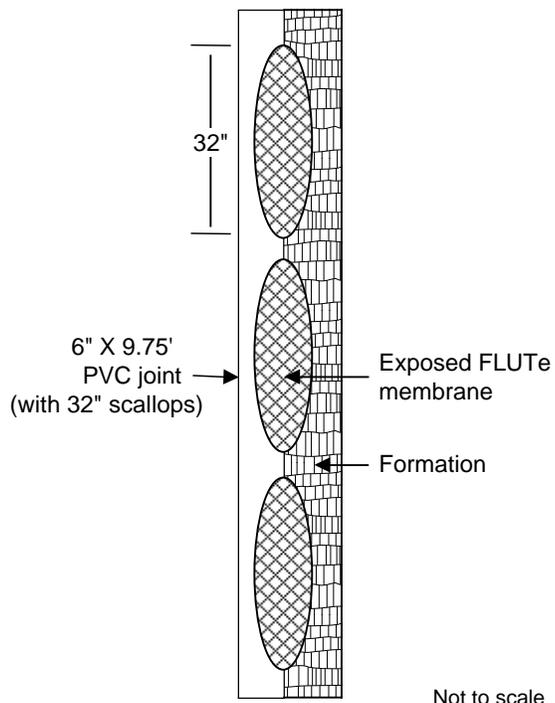
Detail of Scalloped PVC

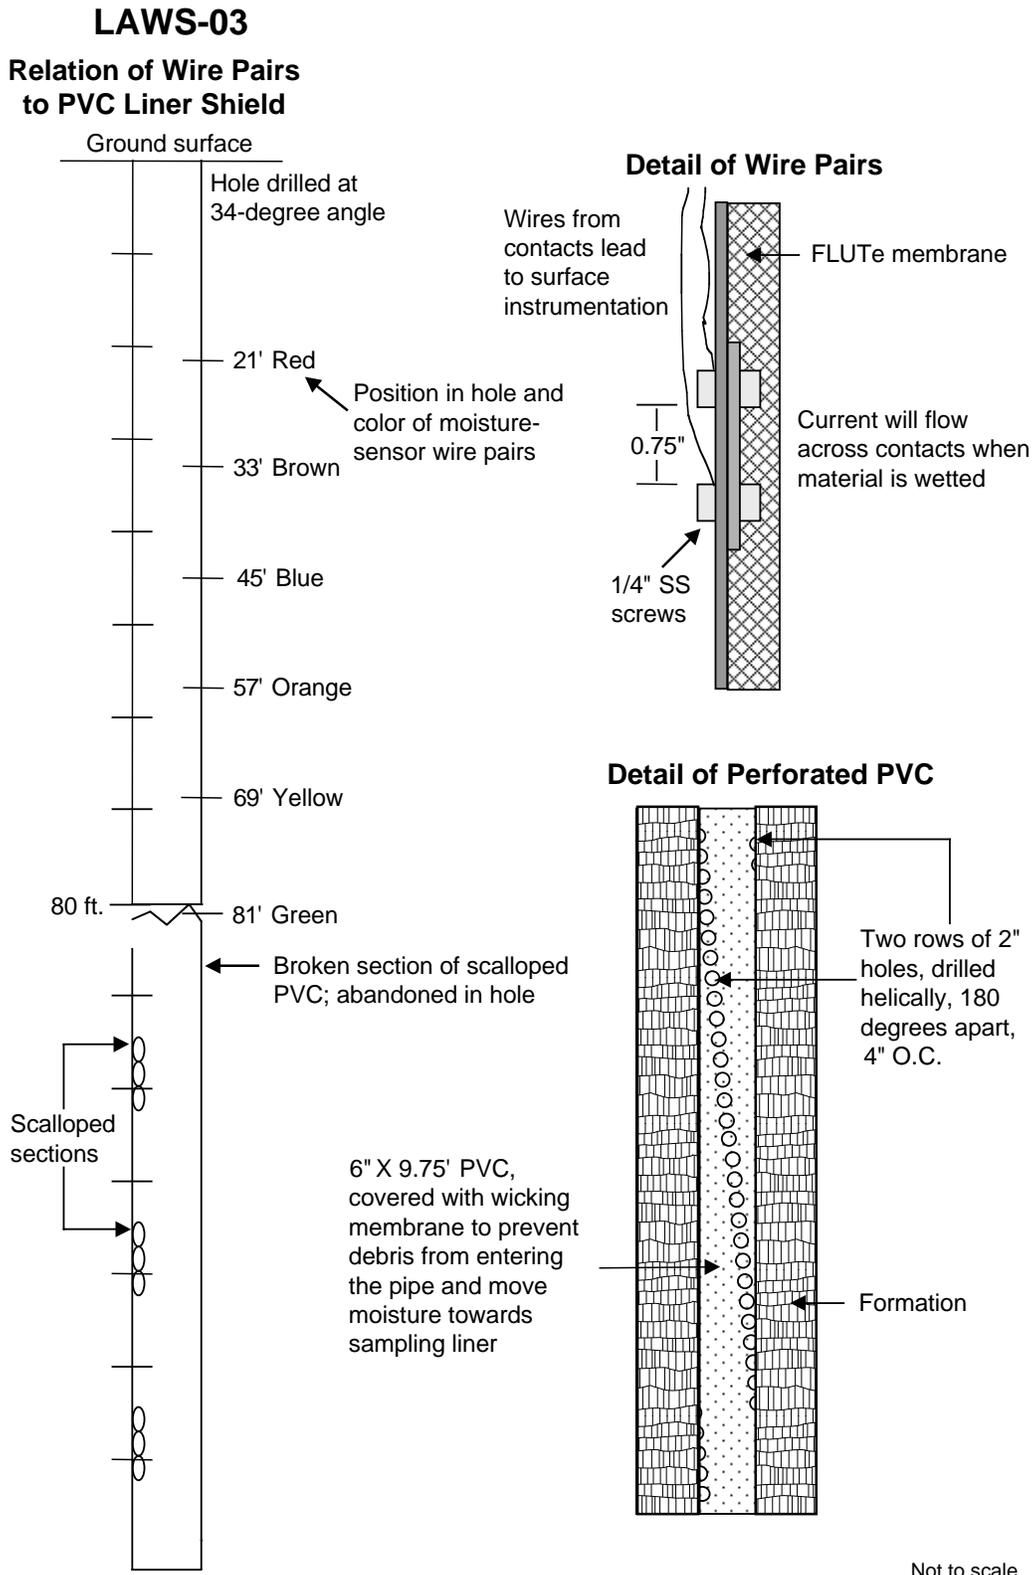
C-2. As-built diagram of the perforated pipe shield used in LAWS-03

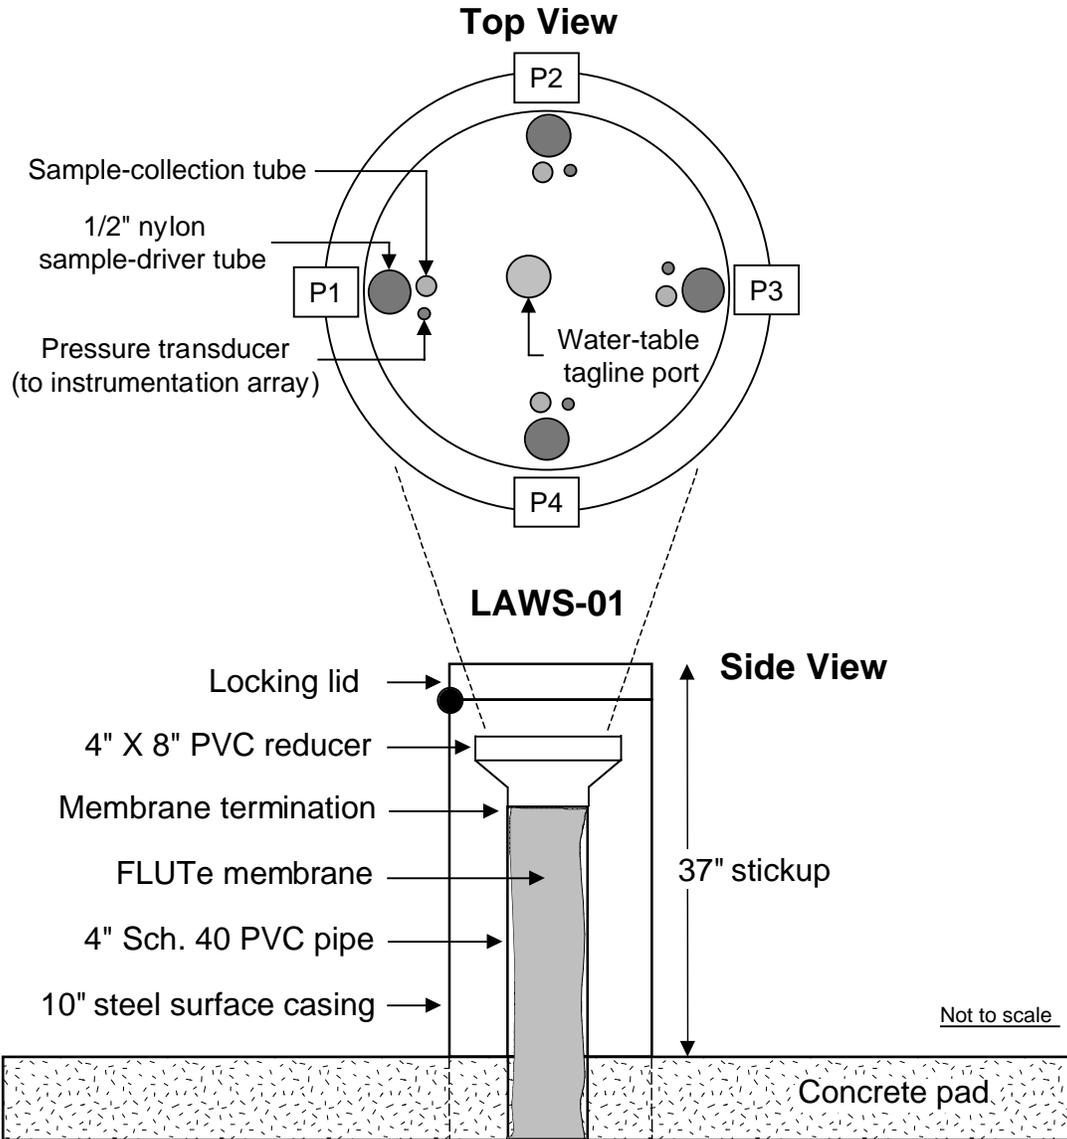
D-1. Schematic diagram of the wellhead at LAWS-01

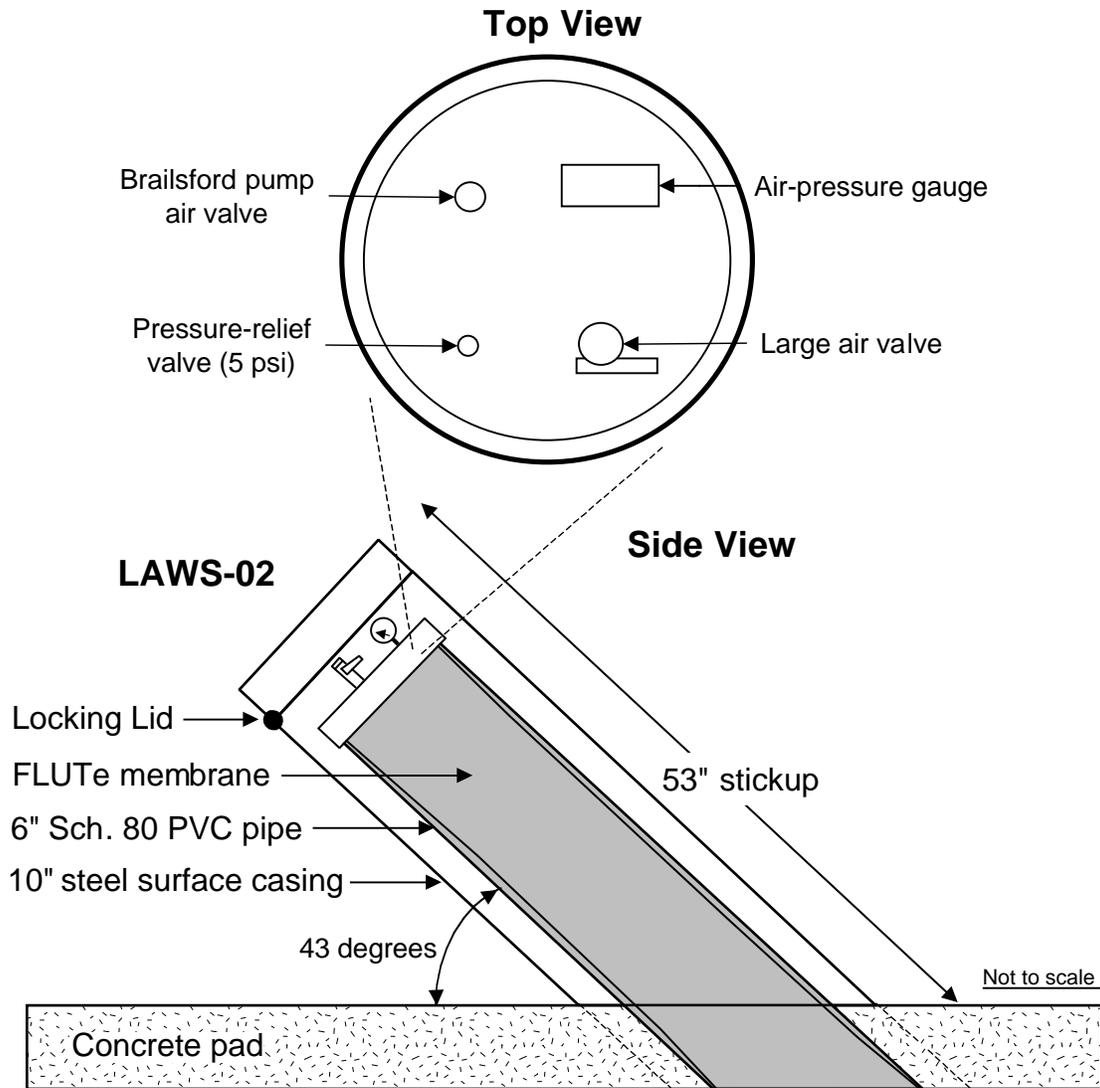
D-2. Schematic diagram of the wellhead at LAWS-02

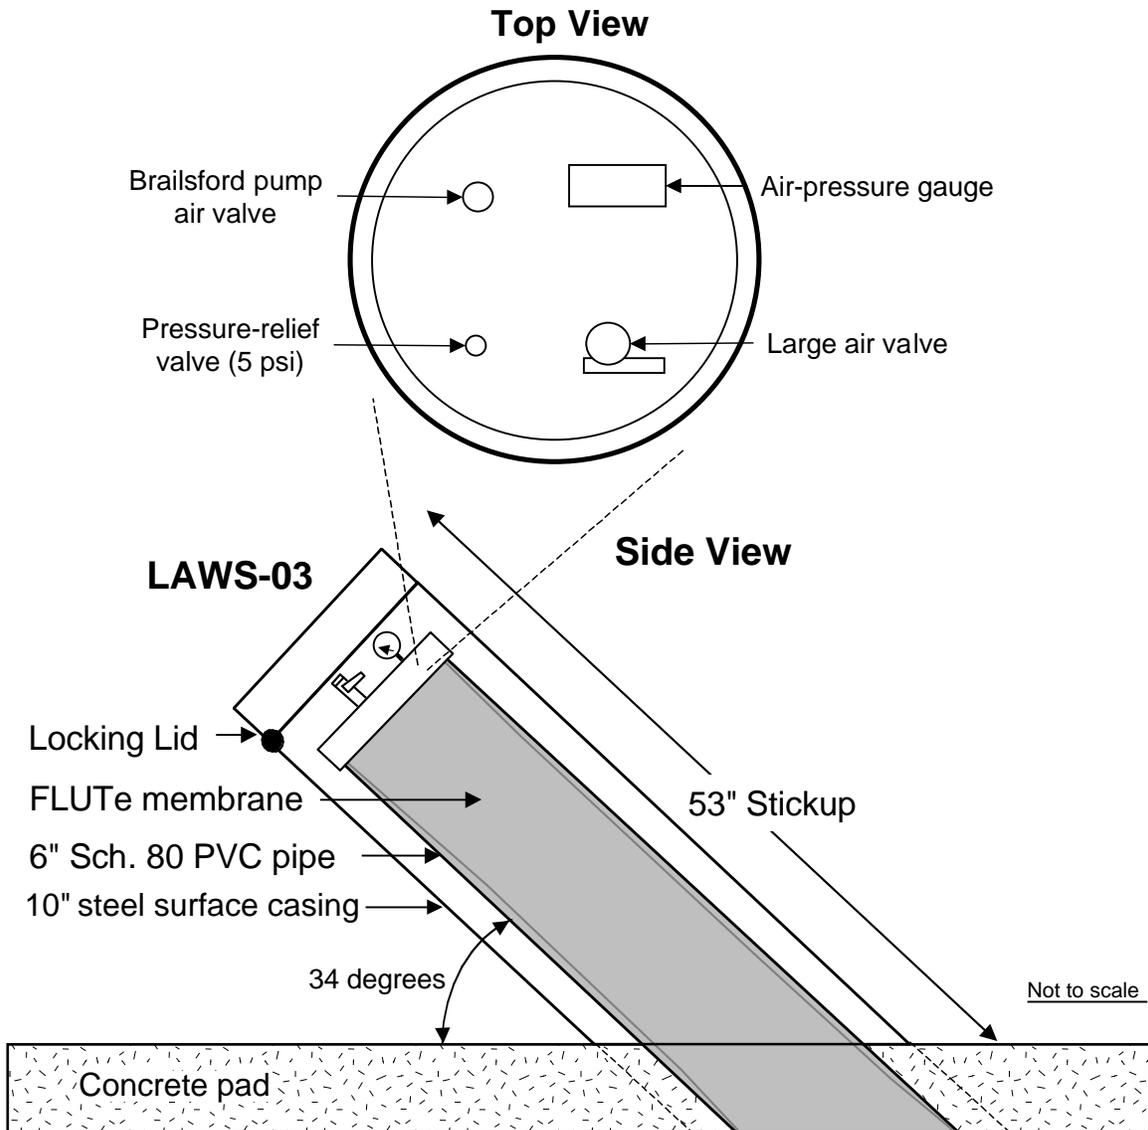
D-3. Schematic diagram of the wellhead at LAWS-03
